STRUCTURAL ASSESSMENT OF MASONRY IN RUINOUS STATE

Typology, materials behaviour, non-destructive techniques and consolidation

(prof. dr. ir.) Luc SCHUEREMANS, Katholieke Universiteit Leuven, Leuven, Belgium

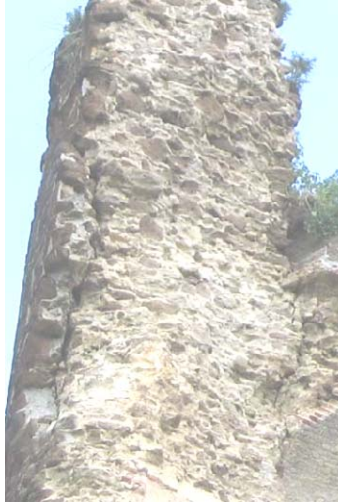
Historical masonry structures encountered in Belgium and nowadays in a ruinous state, often date back from Romanesque and Roman periods. The general layout of these walls consists of three-leaf masonry. A relatively thin external leave of 10 to 30 cm at both external sides and a thick infill masonry of 60 cm up till several meters. The large thickness at the bottom decreases stepwise as function of the height. Besides the difference in thickness in the leaves, the material use is different too. The external leave is built up with (regular) brick or stone masonry, the central leave often is a low quality irregular infill masonry. It consists out of smaller pieces or blocks, gravel, sand and a certain amount of (lime) mortar to increase the bond. For example in the case of the "Maagdentoren" or "Tower of the Virgins", first case study, the tower is a 26 meters high, 15 meters wide ferruginous sandstone tower. The walls have a thickness of 4.2 meters at the base and 1.8 meters at the top, figure 1.

Figure 1. "Maagdentoren" – "Tower of the Virgines" at Zichem (B)

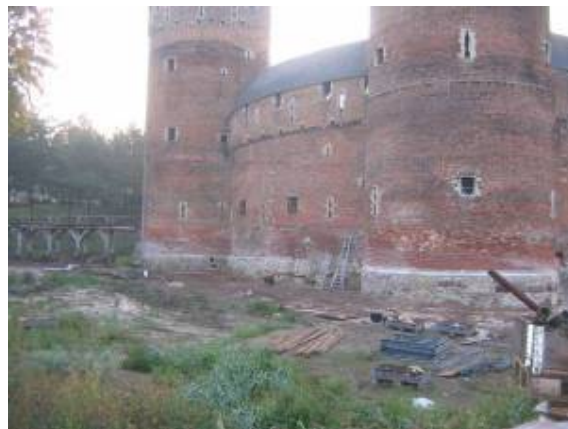
The second case study treats the Castle of Beersel. The bottom part of the external leave is made out of natural stone masonry, with a thickness of 20-30 cm. From on a certain height, the external leave constitutes out of brick masonry with a nominal thickness of 20 cm, figure 2.

Figure 2. "Castle of Beersel (B)

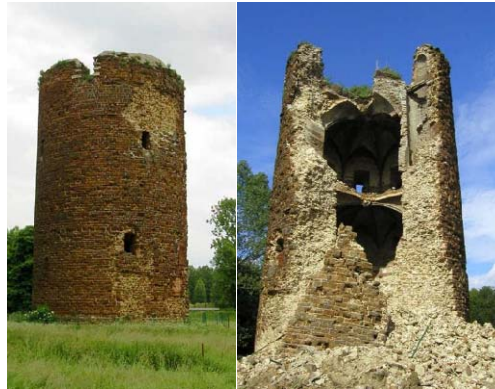
The “Maagdentoren” or “Tower of the Virgins” is located at the bank of the Demer river and is a 26 meters high, 15 meters wide ferruginous sandstone tower, figure 9 (Schueremans, 2010). It was constructed around 1380, intended for residentially, military and prestigiously use. A series of necessary repairs were executed in 1863 and 1905. After that, the tower deteriorated for the rest of the century, resulting in a partial collapse of a part of the outside parement in 1995. The biggest catastrophe occurred on June 1st, 2006, when a huge part of the outside wall collapsed. Figure 1 shows an impression of the masonry cross-section and the loss of bond between the leaves. Figure 9 shows the location on the tower where a dipole-dipole electrode configuration was used to perform a geo-electrical tomography (white line). The survey line of the tomography was deliberately partially placed over a visually good looking part of the wall and a bad looking zone. This visually bad looking zone is caused by the demolition of an historic defence platform that was situated there (see Figure 10-left). Figure 10-

Figure 9. The “Maagdentoren” or “Tower of the Virgins” at Zichem (B) – before and after partial collapse, June 1st, 2006

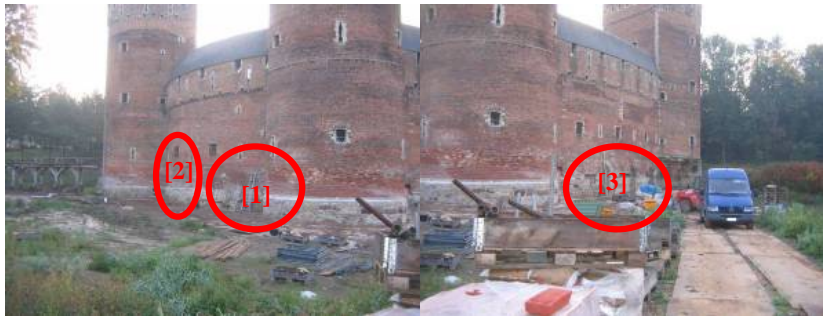
In this case study, the geo-electrical measurement is intended to judge the quality of grout-injections performed as means of consolidation of the masonry. For that reason, the geo-electrical measurements are performed at two stages (Schueremans, 2010). First, a reference measurement is performed before the injection works started. Secondly, the measurement campaign is repeated after consolidation of the masonry using grout injection. Since the geo-electrical measurements give a visual impression of the heterogeneity of the masonry, a comparison before and after injection could enable a qualitative judgement of the consolidation works performed. A total area of about 150 m², figure 11, was monitored before and after grout injection. From that campaign, the areas in which a successful grout injection was obtained could easily be identified, figure 11. In other locations, at which no apparent

Zone [1] – level 18 pseudo-section before injection

Zone [1] – level 18 pseudo-section after injection

Figure 11: Castle of Beersel – measurement areas and example of one of the pseudo-sections before and after grout injection

After injection a more homogeneous resistivity pattern is obtained with on average lower resistivity values.

difference before and after injection could be identified, further investigation was performed, involving adding figures related to the volumes injected in certain areas, and discussion with the contractor performing the injection. As such, without destructive core drillings, the difficulties encountered during the injection were retraced: at specific locations of the masonry the grout penetrability was very limited, at other locations it seemed that the grout flew away towards cavities, etc. As such added value was reached within the overall assessment of the injections performed.

Comparison of the geo-electric pseudo-sections before and after consolidation by means of grout injection gives an impression of the increased homogeneity of the masonry. Similar, again endoscopy can be used and of course a limited number of cores can be drilled to actually check the grout injection performed and strength increase obtained.
